DEPARTMENT OF TRANSPORTATION

Quality Assurance and Source Inspection

Contract #: 04-0120F4Cty: SF/ALA Rte: 80 PM: 13.2/13.9File #: 69.28**WELDING INSPECTION REPORT****Resident Engineer:** Pursell, Gary**Address:** 333 Burma Road**City:** Oakland, CA 94607**Report No:** WIR-000609**Date Inspected:** 12-Oct-2007**Project Name:** SAS Superstructure**OSM Arrival Time:** 630**Prime Contractor:** American Bridge/Fluor Enterprises, a JV**OSM Departure Time:** 1530**Contractor:** Zhenhua Port Machinery Company, Ltd (ZPMC), Changxing Island **Location:** Shanghai, China**CWI Name:** Ye Yongjun**CWI Present:** Yes No**Inspected CWI report:** Yes No N/A**Rod Oven in Use:** Yes No N/A**Electrode to specification:** Yes No N/A**Weld Procedures Followed:** Yes No N/A**Qualified Welders:** Yes No N/A**Verified Joint Fit-up:** Yes No N/A**Approved Drawings:** Yes No N/A**Approved WPS:** Yes No N/A**Delayed / Cancelled:** Yes No N/A**Bridge No:** 34-0006**Component:** Mock Up**Summary of Items Observed:**

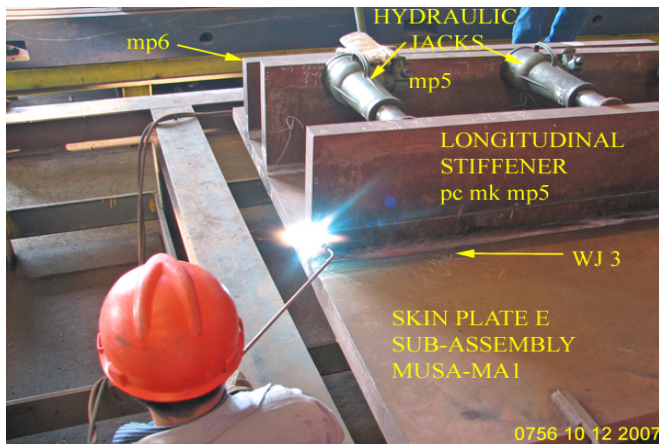
The Caltrans Quality Assurance (QA) Inspector Charlie Franco was present at the time requested to randomly observe welding and associated operations being performed for the fabrication of the Mock Up. The QA Inspector randomly observed ZPMC welding personnel performing heat straightening operations on longitudinal stiffener piece mark mp5 on Skin Plate E, Sub-Assembly (SA) MUSA-MA1. The heat was being applied above Weld Joint (WJ) 3 with hydraulic jacks applying tension from the opposite side. The attached photograph provides additional detail.

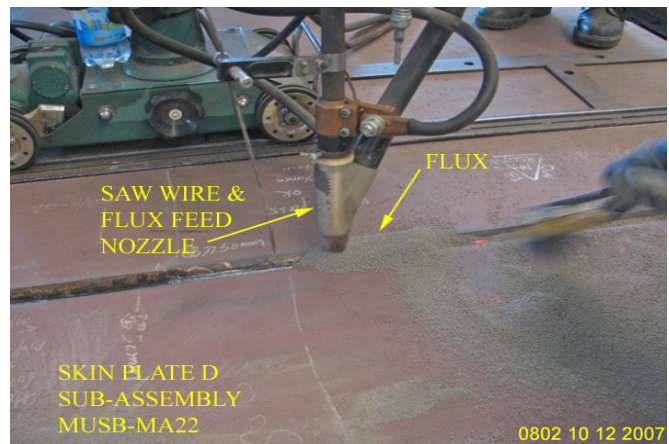
The QA Inspector randomly observed ZPMC qualified welder Han Changou utilizing the Submerged Arc Welding (SAW) process to weld the seam weld on Skin Plate D, SA MUSB-MA22. Mr. Han was utilizing ZPMC approved Weld Procedure Specification (WPS) WPS-B-T-2221-B-U3C-S-1 for the 300 millimeter Complete Joint Penetration (CJP) section of the weld, and ZPMC approved WPS WPS-B-T-2321-B-P3-S-1 for the balance of the

weld which was a Partial Joint Penetration (PJP) weld. The QA Inspector observed ZPMC CWI Xu Le Feng monitoring weld parameters. The QA Inspector also performed random verification of the weld parameters and documented them as follows: welding amperage 623 amps, welding voltage 32 volts with a travel speed of 620 millimeters per minute for side 1 and 624 amps, 32 volts with a travel speed of 576 millimeters per minute for side 2. Weld parameters appeared to comply with the above approved ZPMC WPS. The attached photograph provides additional detail.

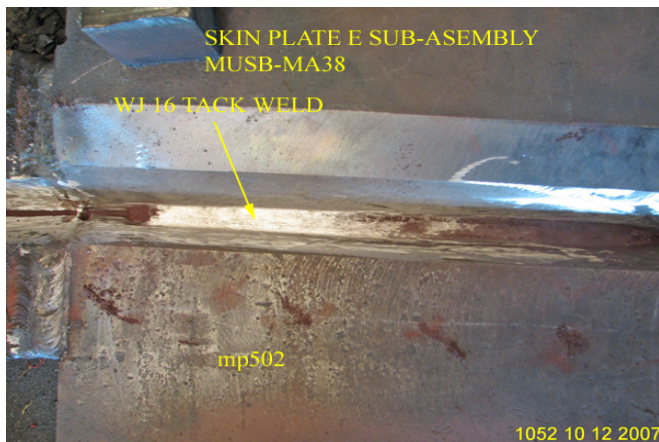
The QA Inspector randomly observed ZPMC Non Destructive Testing (NDT) Technician Zhou Dongyun utilizing the Magnetic Particle Testing Method (MT) to examine 100% of the tack welds in PJP Weld Joint (WJ) number 16, attaching piece marks mp502 to MA38 of Skin Plate E, Sub-Assembly MUSB-MA38. The QA Inspector also performed 100% MT verification examination of the tack welds. There appeared to be no indications. The following photograph provides additional detail.
